Shoreline Restoration Effectiveness in Puget Sound

Recommendations for Improving Project Design

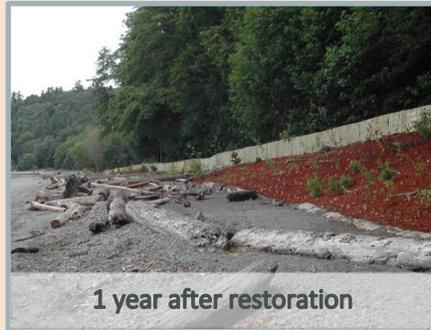
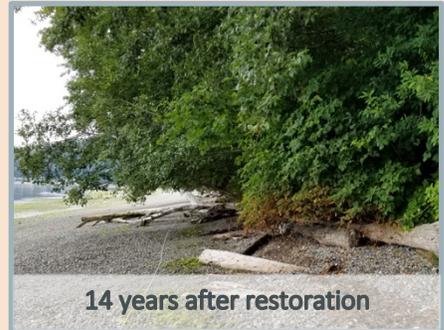
Armor before restoration

1 year after restoration

14 years after restoration

Armor removal and restoration at Seahurst Park, a site of longer-term monitoring.

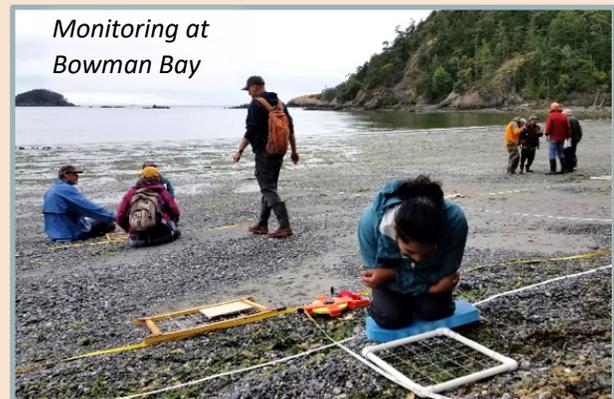
Monitoring at Bowman Bay
